Cooling Tower Restored for 80% Less Than the Cost of Replacement

Cherry Tower

Return full functionality to rooftop BAC cooling tower

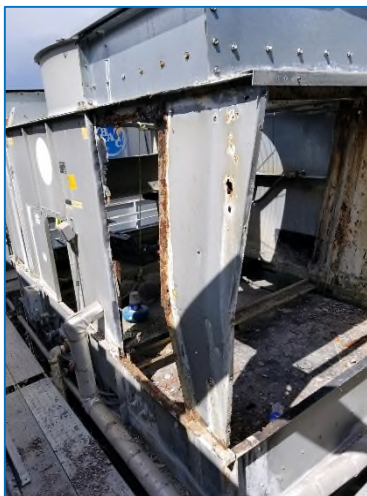
Before

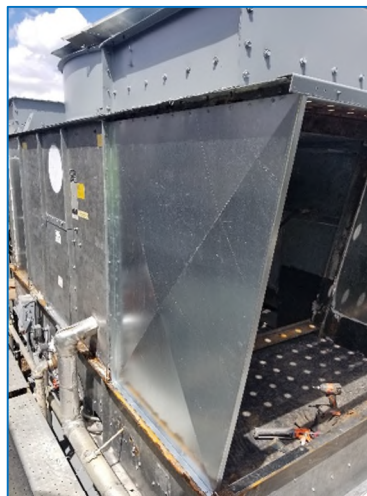
After Sheet Metal Repair

- Clean cooling tower interior and exterior
- Sandblast interior
- Repair cooling tower holes
- Minor repairs, replace pans (as required), and fix damaged sheet metal
- Remove and replace fill eliminators
- Inspect distribution systems
- Coat interior and exterior metal
- Coat structural steel
- Grease shafts and verify bearings

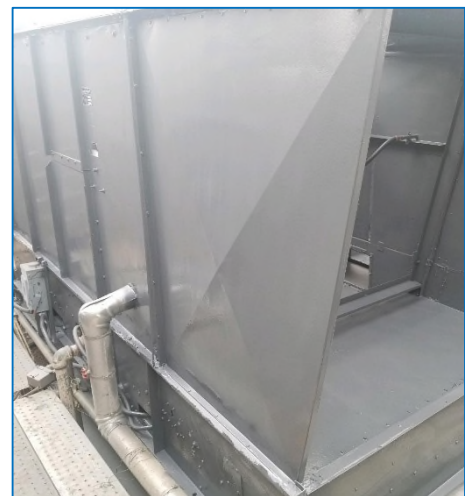
After Coating
